# Pipeline

## Rebuilding America

# HOBAS Pressure Pipes - ASTM Test Proven for Long-Life

# Taking Lubbock by Storm

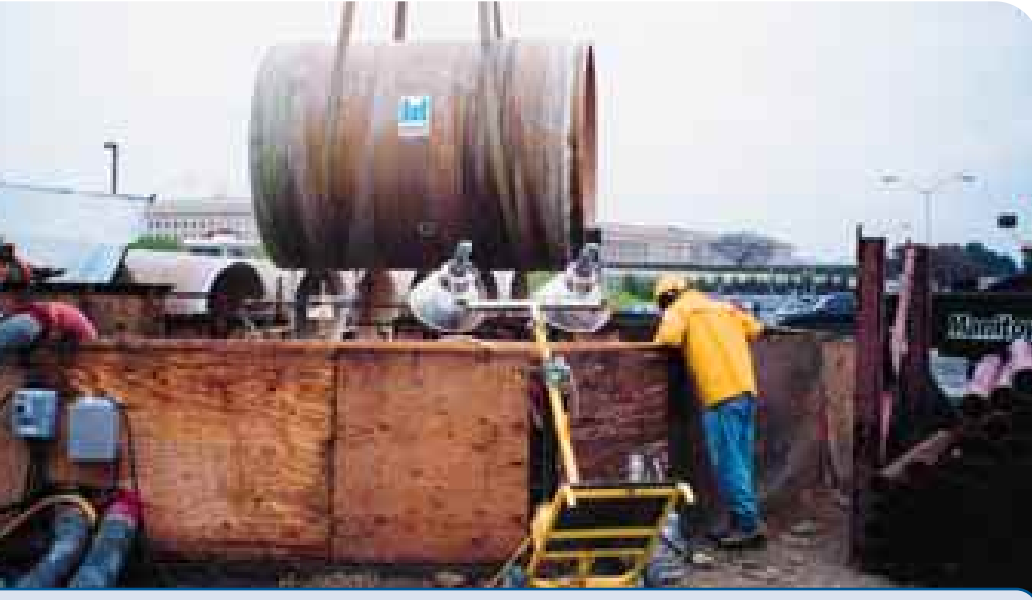
HOBAS PIPES WERE LIGHTER THAN THE CONCRETE ALTERNATIVE.

HOBAS was proposed by Modern Continental Construction Company, Inc. of Cambridge, Massachusetts, the general contractor, due to its size. The nominal 90 inch diameter HOBAS pipe had a much smaller OD than a concrete pipe of the same nominal diameter. The 1,100 ton HOBAS jacking pipe had an outside diameter of 94 1/4 inches while maintaining an inside diameter of 88 3/4 inches. A similar concrete jacking pipe would need a wall thickness of roughly nine inches. This wall thickness, nearly three times that of HOBAS, would also increase the pipes weight per foot by 50 percent.

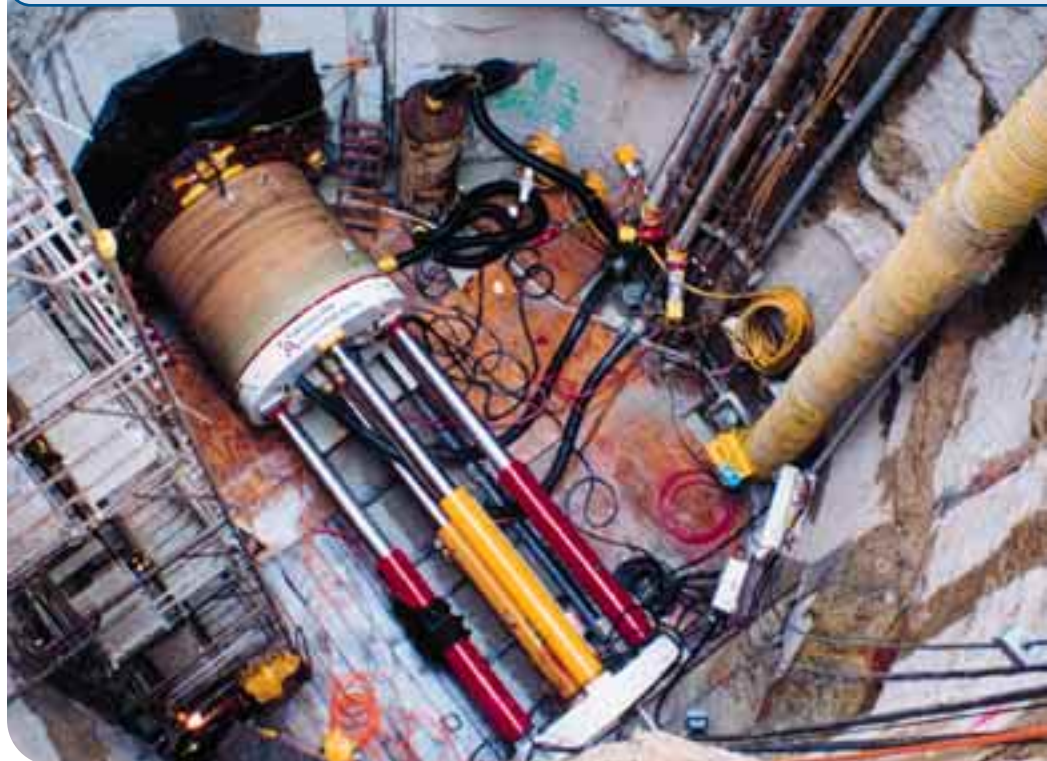
SMOOTH NON POROUS OD OF THE HOBAS PIPE CREATES LESS FRICTION.

Aside from the OD providing a perfect match to some of their existing jacking equipment, Philippe Hewes with Modern Continental stated the "smooth OD creates less friction lowering jacking forces." The actual jacking forces on the project did not exceed 500 U.S. tons and were usually in the 300 ton range. Phil also noted that the smooth ID of the pipe provides excellent hydraulics. This benefit was also recognized by Arlington, VA office of Jacobs/Sverdrup that provided engineering direction for the design build project.

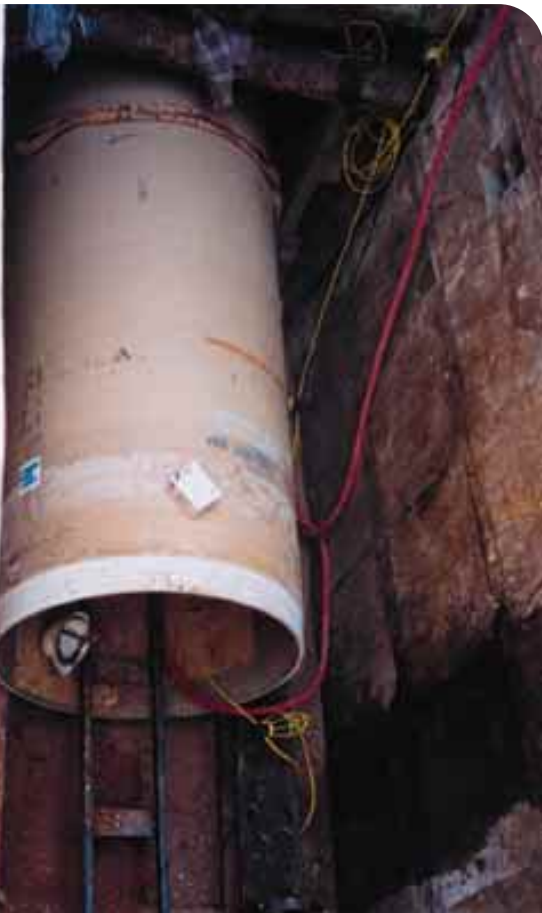
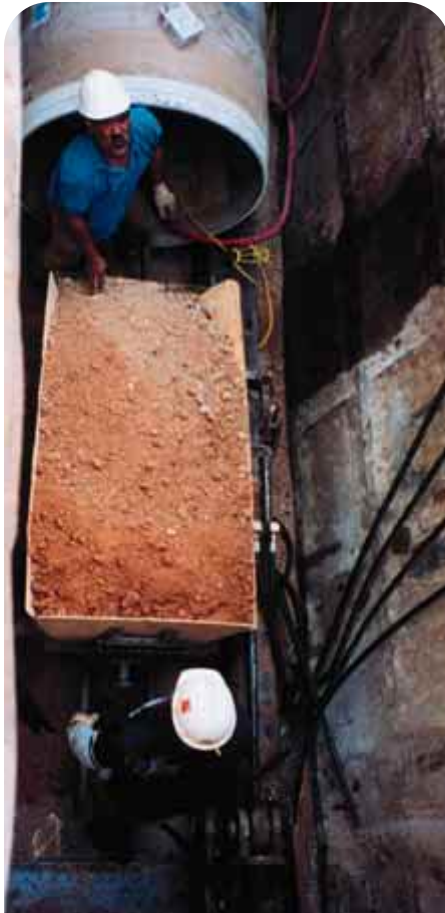
SPOIL WAS REMOVED FROM THE TUNNEL VIA MAN RIDDEN CARS, AND A RAIL SYSTEM ON THE INTERIOR OF THE HOBAS PIPES.

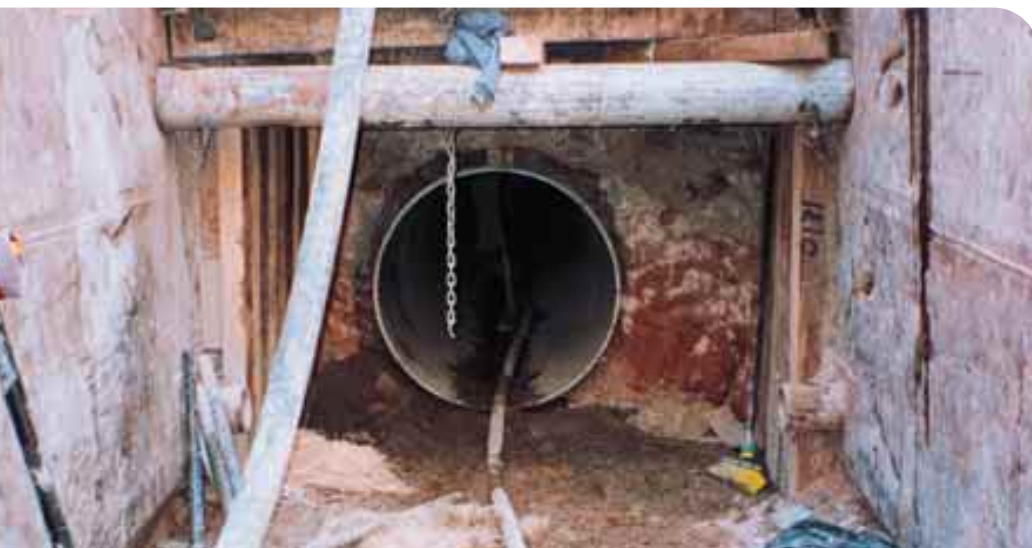
THE HOBAS PIPE WAS INSTALLED DIRECTLY WITHIN THE ROCK TUNNEL AT DEPTHS OF UP TO 50 FEET.

became functional. Additional inlets were later opened and the entire system is now operational. The project included more than 10,000 feet of HOBAS CCFRPM pipes ranging from 24-inch to 72-inch diameter at depth of over 50 feet. The majority of the HOBAS was installed by tunneling methods, either by itself or within a primary liner.

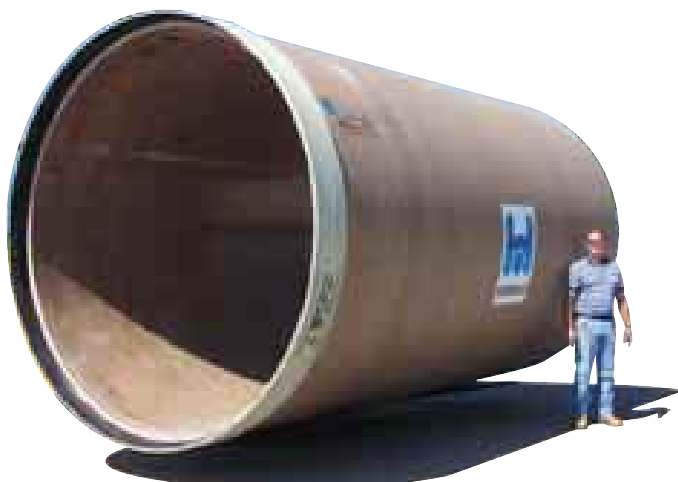
▶ HOBAS has again expanded the product line to meet the needs of our customers. The latest addition to the diameter range, includes a 110 inch nominal diameter pipe. Pipes for direct bury, sliplining, jacking and other applications are now available in this diameter. ●

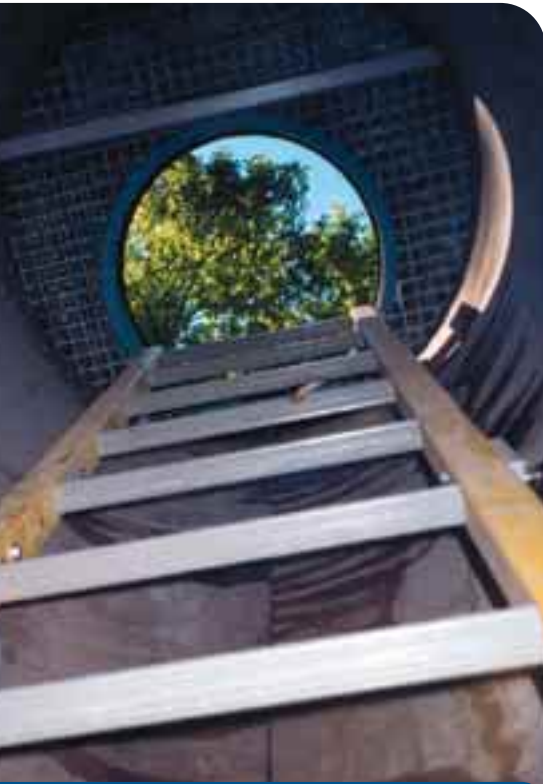
THE ALL FIBERGLASS SYSTEM IS CORROSION RESISTANT AND WATER TIGHT.

The specifications included 8,000 feet of pipe - 2,100 feet of 48-inch, 3,700 feet of 60-inch and 2,200 feet of 66-inch. The alternatives were profile wall polyethylene and centrifugally cast, fiberglass-reinforced, polymer mortar (HOBAS CCFRPM) pipe. Neither of these is affected by hydrogen sulfide as unlined concrete pipe would be.

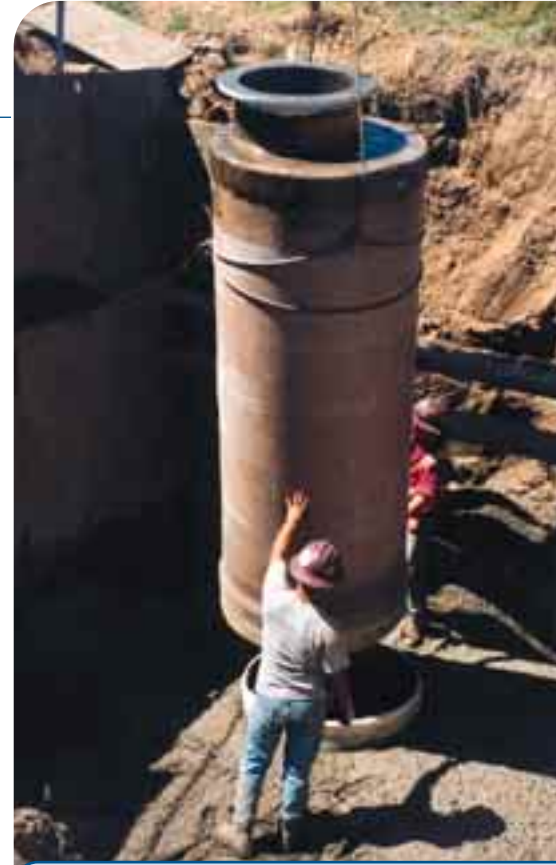
THE HOBAS RISERS WERE SIMPLY ATTACHED WITH AN FWC COUPLING.

The 48-inch diameter manhole risers were reduced to a standard 24-inch top. HOBAS also made the manhole covers, which were attached with a gasket and bolts ensuring they would be watertight as the summer water levels rise. “HOBAS supplied a complete package,” Lampert continued. By providing the pipe, manhole tee bases, risers and lids, HOBAS makes jobs convenient for the contractor.

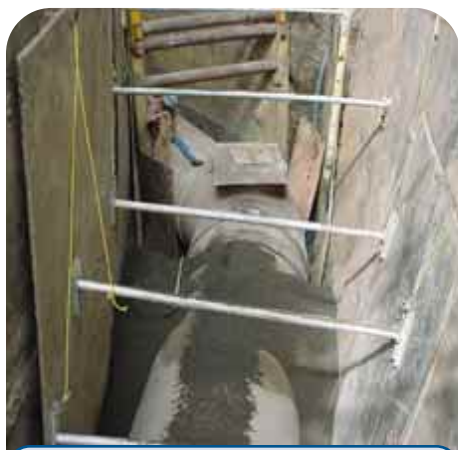
CUSTOM MITERED ELBOWS WERE MANUFACTURED TO FOLLOW THE MEANDERING STREAM.

In order to accommodate the many changes on the sewer line as it followed the meandering creek, Jersey installed manholes. It wasn't uncommon to have a series of manhole runs of only: 100 feet, 70 feet, 130 feet then 500 feet. "The custom-made manholes simplified this task," Kalkhoven said. HOBAS manufactured each manhole with the correct miter and FWC couplings so that they were easily joined. "For the first 2,000 feet of pipe, we were limited to an easement 30 feet

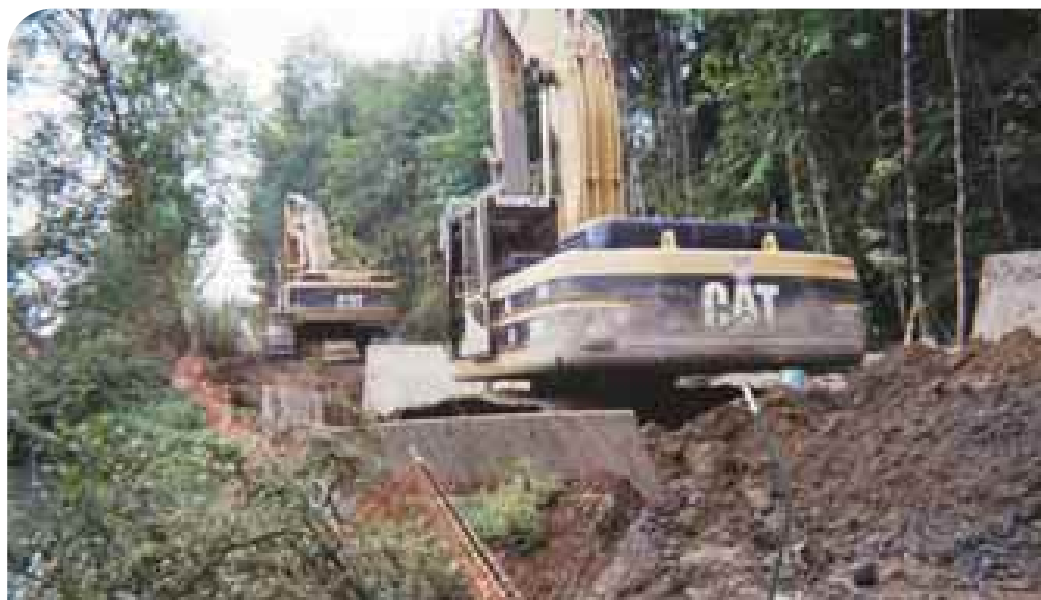
LIGHTWEIGHT GASKET SEALED HOBAS PIPES WERE EASILY HANDLED IN THE NARROW PATHWAY.

wide,” explained Kalkhoven. “Since the excavation for the 66-inch pipe was eight feet wide, we had an eleven foot path to bring everything in. All the pipe and bedding had to come from behind but this was no problem. We’d lay the pipe, then install the tee-base manhole and proceed to the next joint. After the manhole bases were installed, we put the risers in place and added the cover. The risers were delivered complete including fiberglass ladders.”
