Michigan Ditch Rehabilitation Project

Bull's Bridge Replacement Penstock

LNVA Repairs Jones Crossing at the Devers Canal

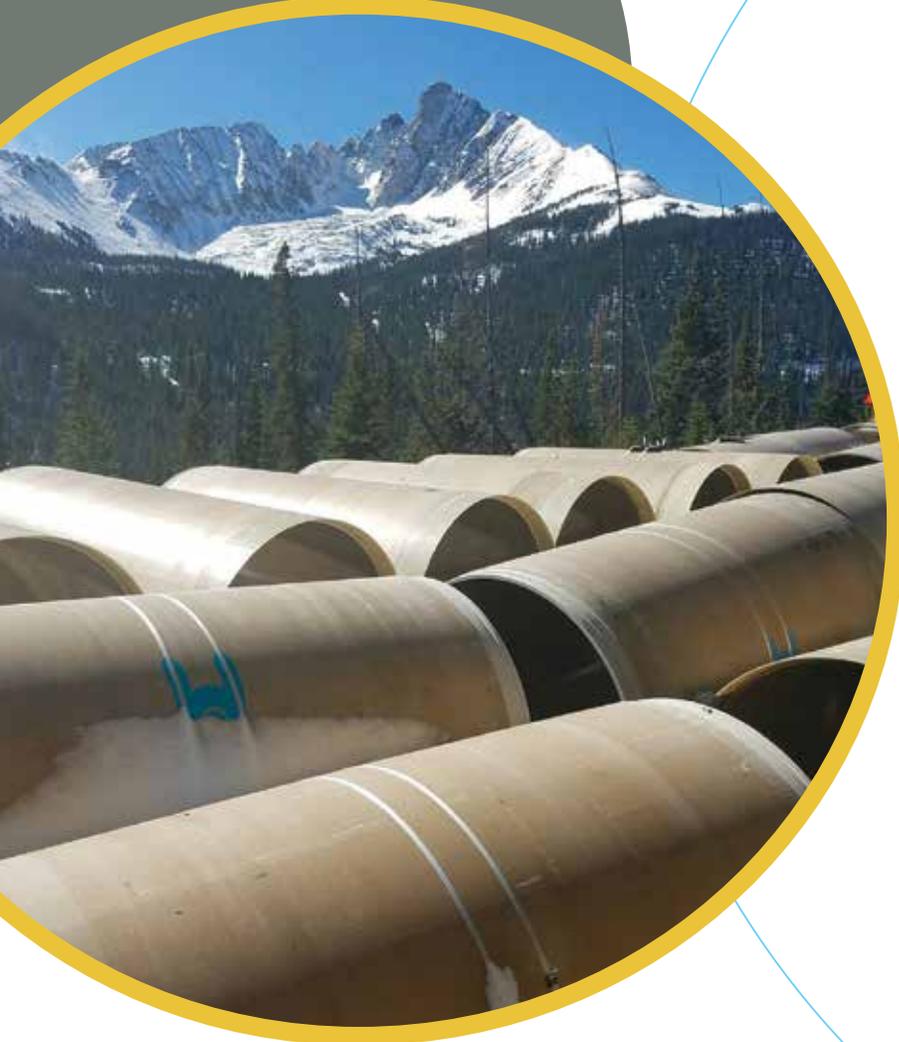
BELOW

Manufactured in ten foot sections, lightweight CCFRPM was easier to maneuver on the narrow job site.

curve alignment, it was easier to maneuver the shorter sections on the narrow job site than the standard 20 foot lengths.

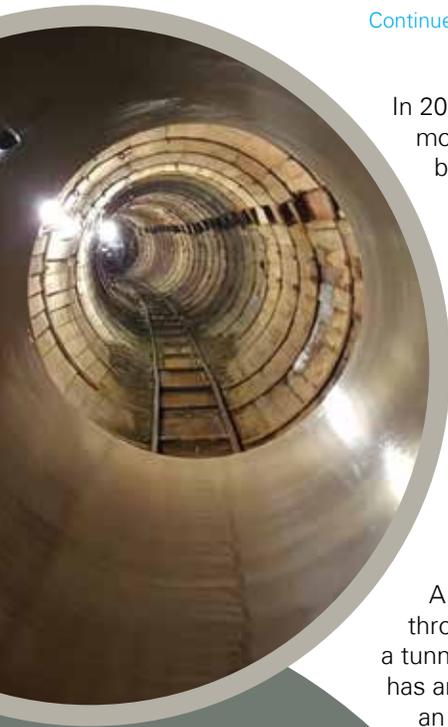
OPPOSITE

765 feet of 60-inch HOBAS pipe was inserted into the primary tunnel to serve as the carrier pipe for the water.

A 765-foot-long curved tunnel was bored through the side of the mountain using a tunnel boring machine (TBM). The tunnel has an outside diameter of 96-inches and an initial support of steel rib and wood lagging. Following tunnel construction, 765 feet of 60-inch HOBAS pipe was inserted into the primary tunnel to serve as the carrier pipe for the water. The pipe for the tunnel was manufactured with a stiffness class of SN 62, in 10 foot sections, with a flush joint configuration that was blocked into place and subsequently grouted. BT Construction, Inc. was the installation contractor for the tunnel. Due to soil and ground conditions, the tunnel was designed with a slight curve. "It was determined that a 0.9 degree deflection for every ten foot joint would match up quite well with the Flush Reline pipe (1.2 degrees max)," said Beckos.

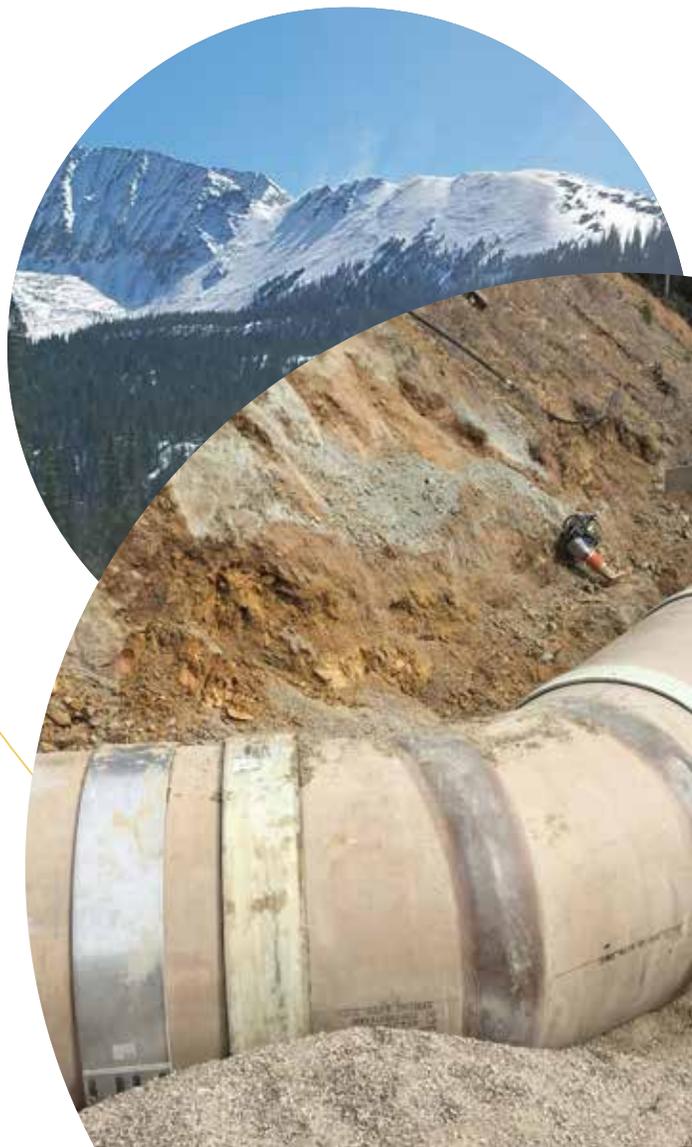
CENTER

Three elbows were provided for the upstream and downstream angles. The elbows enabled the tunnel pipeline to be re-aligned with the open cut ditch system.

The open cut section was installed by Hydro Construction of Fort Collins, CO. This section consisted of 64 feet of pipe on the upstream side and 137 feet of pipe on the downstream side. These sections of pipe were also 60-inch pipe, stiffness class SN 46 and supplied in 10-foot sections. Three elbows were provided for the upstream and downstream angles.

"The elbows enabled the underground tunnel pipeline to be re-aligned to match up with the open cut ditch system," said Beckos.

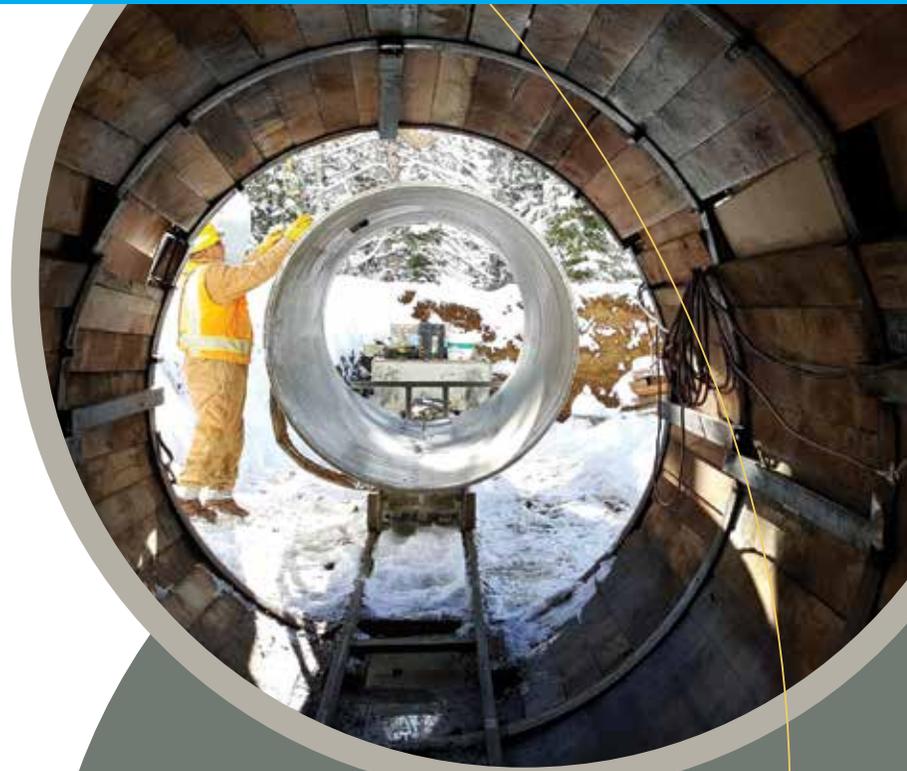
ABOVE

An Akkerman 1548 Haul Unit with an empty dolly and a custom built pipe carrier was used to drive the pipe into the tunnel.

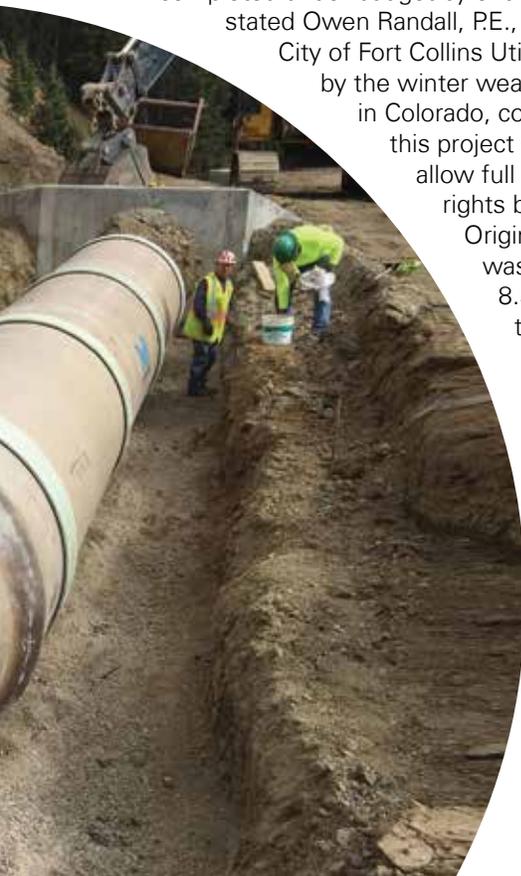
OPPOSITE
Lightweight 120-inch CCFRPM pipe installed underneath Bull's Bridge.

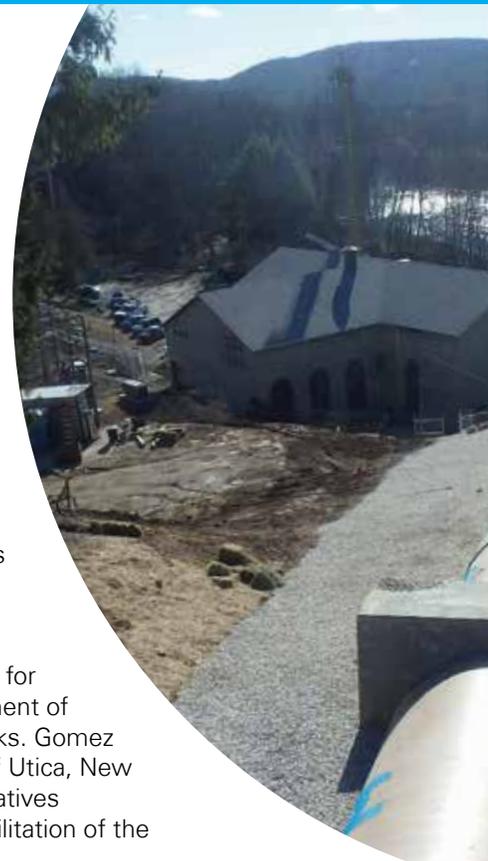
CENTER LEFT
Fill material was placed approximately two feet above the pipe centerline, leaving three feet exposed.

The new penstocks were partially buried utilizing no cradles for support. The fill material was placed to about two feet above the pipe centerline, leaving three feet exposed. The CCFRPM pipe was designed and manufactured with an operating pressure of 50 pounds per square inch (psi) to accommodate the operating pressure of the line. The penstock was put into service during winter 2015. [H](#)

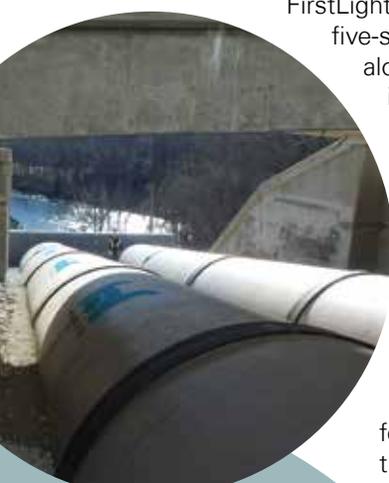
CENTER RIGHT
An on-site transportation device used to install the pipe under the bridge was designed by Bancroft Contracting, Corp.

An ingenious on-site transportation device used to install the pipe under the bridge was designed by the installation contractor, Bancroft Contracting Corp. of South Paris, Maine. "The rig involved a long I-beam connected to a column," explained Sawyer. "The column was composed of two hollow steel square tubes with one sliding inside the other and held in place with steel pins. Wheels were attached to the bottom of the

column. The end of the beam not connected to the column was attached to the arm of an excavator which could then drive the rig through a section of pipe and extend the column to lift the pipe off the ground. Then the rig was driven up to an installed section of pipe and the column could be lowered to drive the rig into the installed pipe and butt the new section of pipe against the installed section."

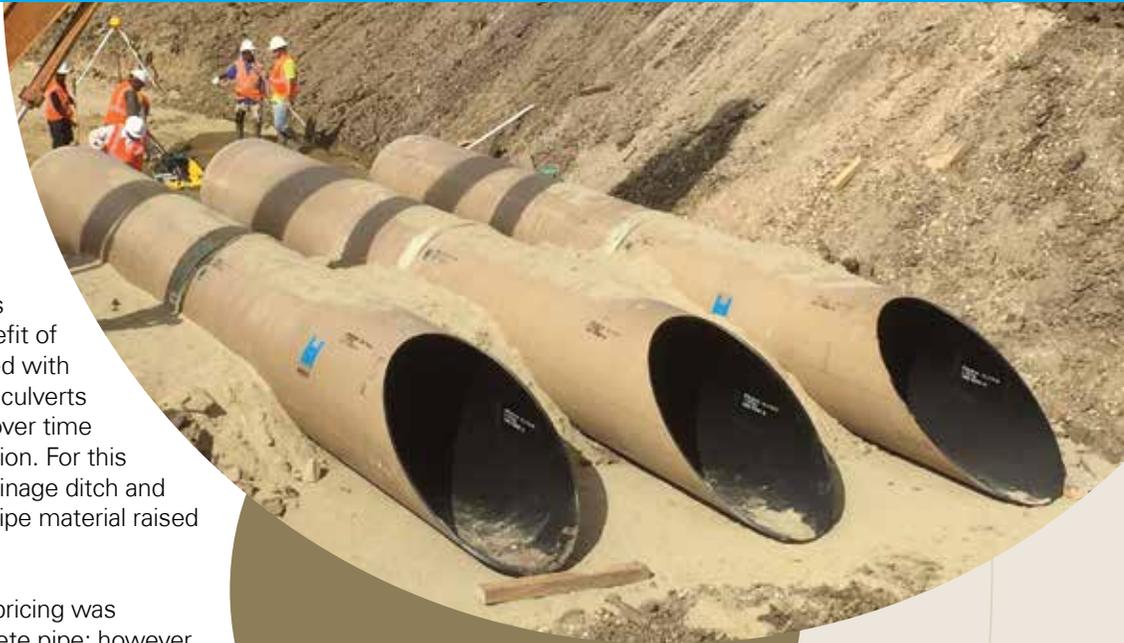
LNVA crews installed 600 feet of 48-inch HOBAS pipe relatively easily with no previous experience installing this type of pipe.

The installation of the three 160-foot runs in the drainage ditch took four days, while installation of the three 40-foot runs in the canal under the roadway was completed in only one day. Once the new HOBAS pipe was installed, LNVA crews re-graded the drainage ditch slopes and reconstructed the canal banks and rock road back to their pre-existing grades. Because repairs to the roadway and canal system were performed in the agricultural off-season, the road was closed for duration of construction, as no residences or local traffic were affected.
